PHOTOGRAPHIC INTERPRETATION REPORT

HARDENED CENTRAL COMMAND FACILITIES MOSKVA AREA, USSR

SEPTEMBER 1966

NATIONAL PHOTOGRAPHIC INTERPRETATION CENTER

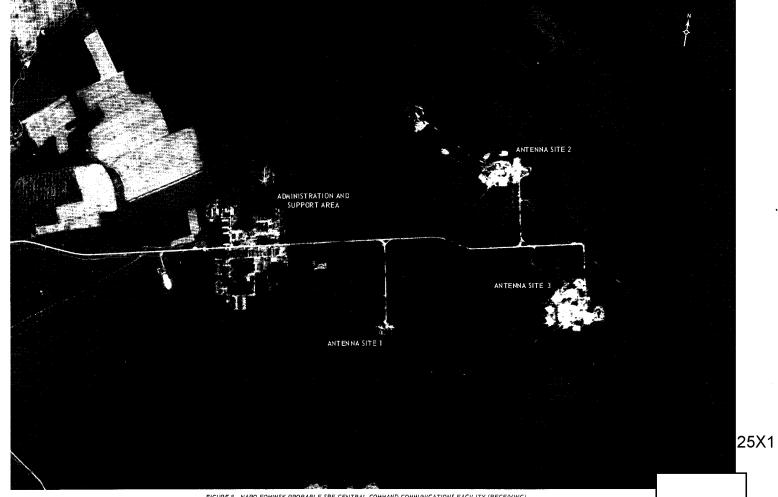
FIGURE 8. NARO-FOMINSK PROBABLE SRF CENTRAL COMMAND COMMUNICATIONS FACILITY (RECEIVING).

Antenna Site 1. Antenna Site 1 (Figures 8 and 9) contains 10 fishbone and 6 horizontal dipole antennas including 2 possible horizontal dipole antennas. Antenna number 4 on Figure 9 is a long-distance fishbone receiving antenna and the remainder of the antennas in this site are shortand medium-distance dipole and fishbone antennas. This, the original antenna site in this facility, was first observed photography.

Antenna Site 2. Antenna Site 2 (Figures 8 and 9) contains a very large earth-mounded control building (Figures 6 and 10) which is basically rectangular in shape, but with an annex on one end. The overall dimensions of the control building and annex are approximately 285 feet by 260 feet, with the main building approximately and the annex approximately 100 by 100 feet. The earth-mounded control building is surrounded by 8 hardened (subsurface) antennas, 14 fishbone receiving antennas, and 3 horizontal dipole antennas. Earth scarring in the area where an earth-mounded building was subsequently con-

Antenna Site 3. Antenna Site 3 (Figures 8 and 9) is similar in appearance and development to Antenna Site 2, and contains a very large earth-mounded, control building with an annex on one end (Figures 7 and 11). The overall dimensions of the control building and annex are approximately 290 feet by 265 feet, with the main building approximately 265 feet by 220 feet, and the annex approximately

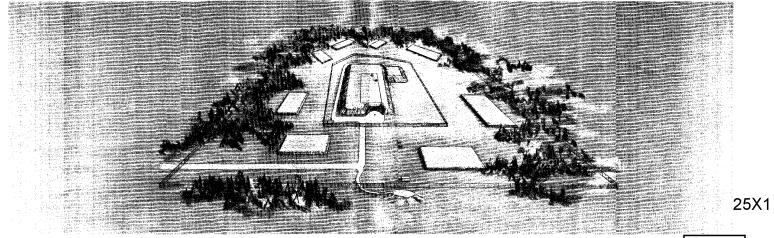
FIGURE 10. PERSPECTIVE VIEW OF ANTENNA SITE 2, NARO-FOMINSK.

structed may be observed on ________ The control building is double fenced; the outer or perimeter security fence was constructed around the area of the control building during an early stage of construction; the inner security fence surrounds the control building and the loop service road. Eight hardened (subsurface) antennas are arranged in a symetrical pattern around the control building, between the 2 fences. No guard or light towers have been identified. Antennas numbered 29, 19 and 18, 26 on Figure 9 are paired long-distance fishbone antennas. Some of the other 13 fishbone antennas are also paired. The dipole antennas are of the short- and medium-distance type. The small rectangular building that is on the access road and in front of the earth-mounded control building appeared at approximately the same time as the radial antenna pattern. It is possible that this structure was used for operational testing of the communications equipment while the earth-mounded building was under construction.

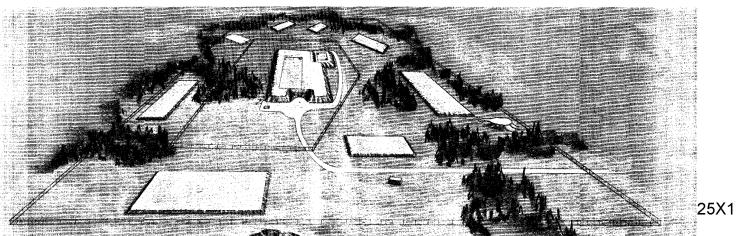
FIGURE 11. PERSPECTIVE VIEW OF ANTENNA SITE 3, NARO-FOMINSK.

110 feet by 110 feet. The control building is surrounded by 8 hardened (subsurface) antennas, 16 short- and medium-distance fishbone receiving antennas including 1 probable fishbone antenna, and 2 horizontal dipole antennas. Antennas numbered 46 and 36 on Figure 9 are paired long-distance fishbone receiving antennas. Each of these antennas is approximately 900 feet long.

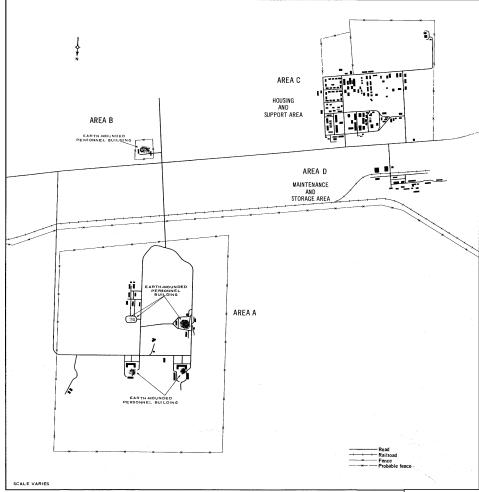
FIGURE 22. LAYOUT OF SHARAPOVO CENTRAL COMMAND CONTROL FACILITY.

The maintenance and storage area, designated Area D, is both rail and road served, and contains approximately 15 buildings including 2 assembly-type buildings. The presence of this area with an adjacent rail spur indicates the augmented capability of the Sharapovo facility not at the Perkhushkovo, Chernoye, and Chekhov facilities.

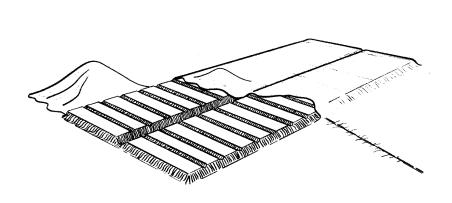
FIGURE 30. PERSPECTIVE VIEW OF A SOVIET HARDENED (SUBSURFACE) ANTENNA UNDER CONSTRUCTION.

the dipoles reasonably dry as the top of the grid is slightly above the normal level of the earth's surface and the antenna presents a low profile. The dipoles of the antenna are center fed as noted from the conspicuous trench which bisects the array. Transmission line attenuation is apparently critical because the antennas are always placed close to the earth-mounded control building.

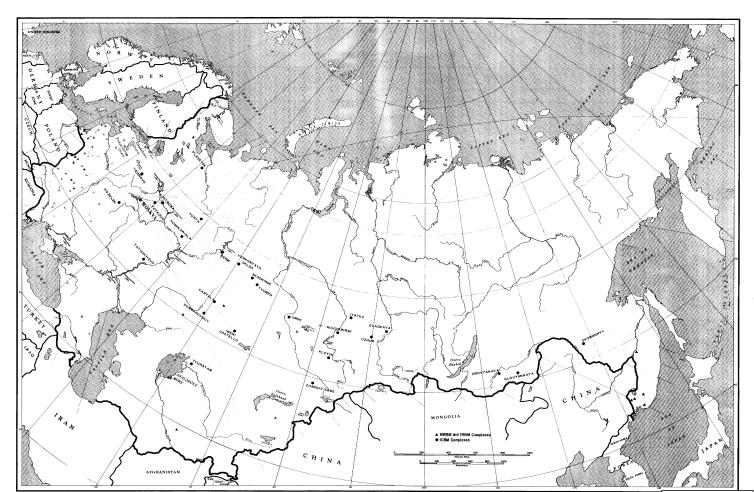
FIGURE 31. APPROXIMATE AZIMUTH PROJECTIONS OF PRINCIPAL HF ANTENNAS AND ANTENNA GROUPS AT NOVOPETROVSKOYE.

A construction chronology of this facility is included in Appendix B. This chronology is followed by maps showing the approximate azimuth projections of the HF antennas and antenna groups (Figure 31), the approximate azimuth projections of the hardened (subsurface) antennas (Figure 32), and Table 1 which contains the antenna azimuths, designations, types, and possible correspondents.

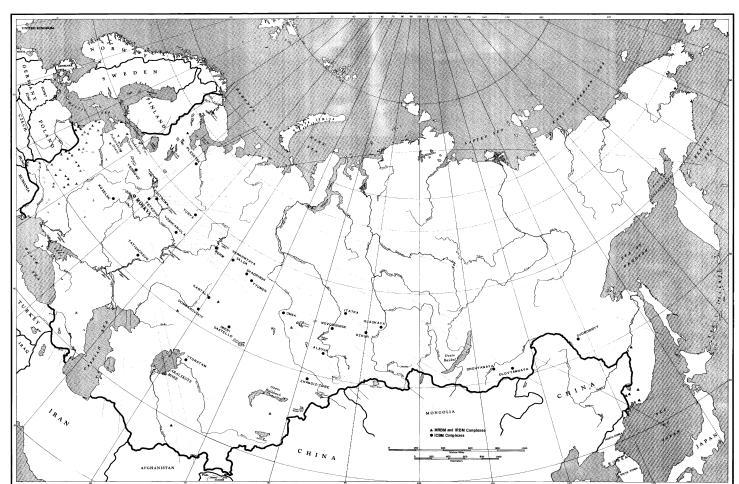
FIGURE 33. APPROXIMATE AZIMUTH PROJECTIONS OF PRINCIPAL HF ANTENNAS AND ANTENNA GROUPS AT NARO-FOMINSK.

A construction chronology of this facility is included in Appendix B. This chronology is followed by maps showing the approximate azimuth projections of the principal HF antennas and antenna groups (Figure 33), the approximate azimuth projections of the hardened (subsurface) antennas (Figure 34), and Table 2 which contains the antenna azimuths, designations, types, and possible correspondents.

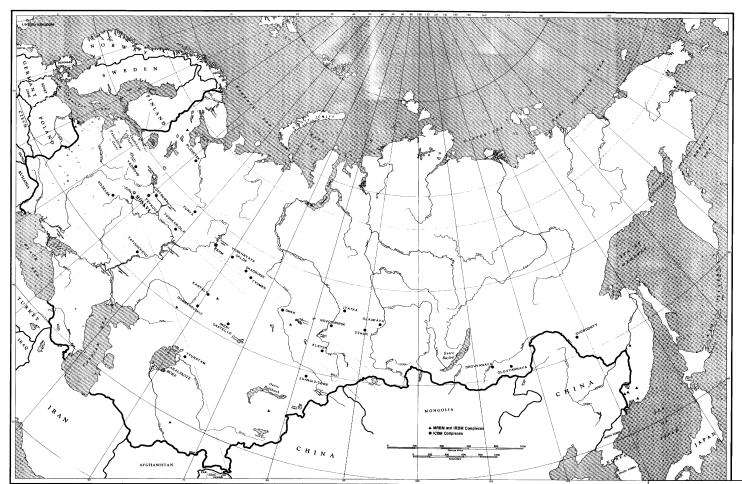
FIGURE 35. APPROXIMATE AZIMUTH PROJECTIONS OF PRINCIPAL HF ANTENNAS AND ANTENNA GROUPS AT RAMENSKOYE.

A brief construction chronology of this facility is included in Appendix B. This chronology is followed by maps showing the approximate azimuthal projections of the principal HF antennas and antenna groups (Figure 35), the approximate azimuthal projections of the hardened (subsurface) antennas (Figure 36), and Table 3 which contains the antenna azimuths, designations, types, and possible correspondents.
